Eelgrass Restoration Project Update

11-30-05

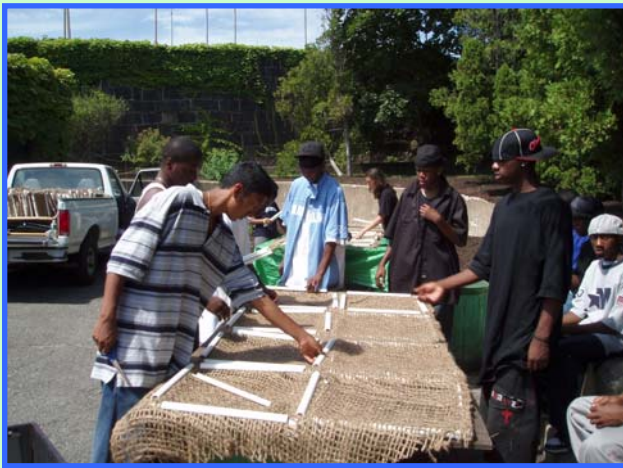
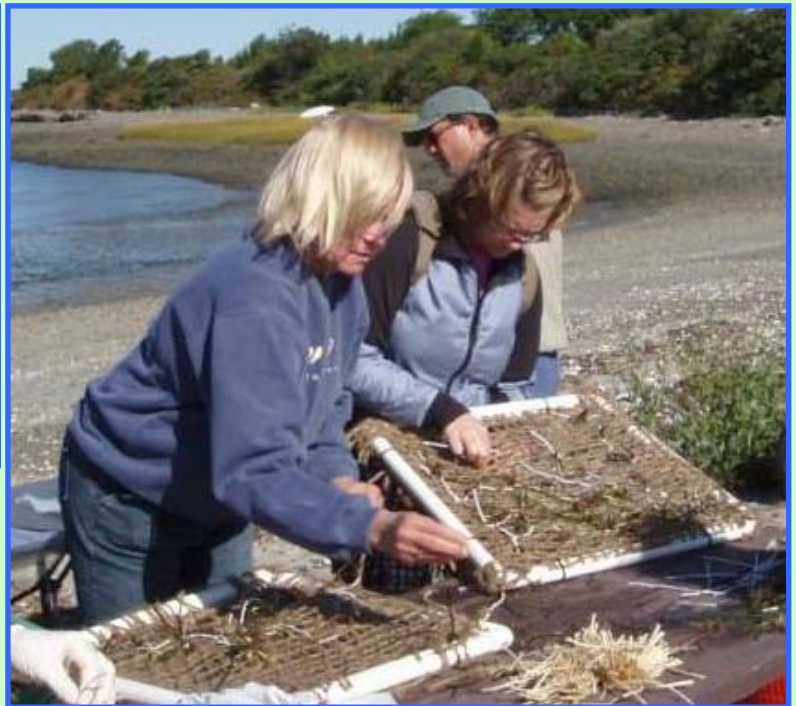
Figure 3. Volunteers building PVC/jute frames (upper left), tying eelgrass shoots to PVC frames (right) and hand-planting eelgrass (lower left).

We developed a lighter and lower profile alternative to the wire mesh TERF™, making it easier to handle. It is a ¼ m square, 3/4 " PVC pipe frame holding stretched jute (landscape) mesh to which shoots are tied. Upon deployment and rooting of attached shoots, the jute can be easily cut from the inside of the frame, leaving it to biodegrade while the frames are retrieved for reuse. We used only PVC frames at the Weymouth site, where hand-planting would reduce visibility by stirring up soft sediment. In contrast, only hand planting was used at Peddocks Island, where gravel prevents frames from lying flat against the bottom. Both methods were used at Long Island where the sediment is sandy.

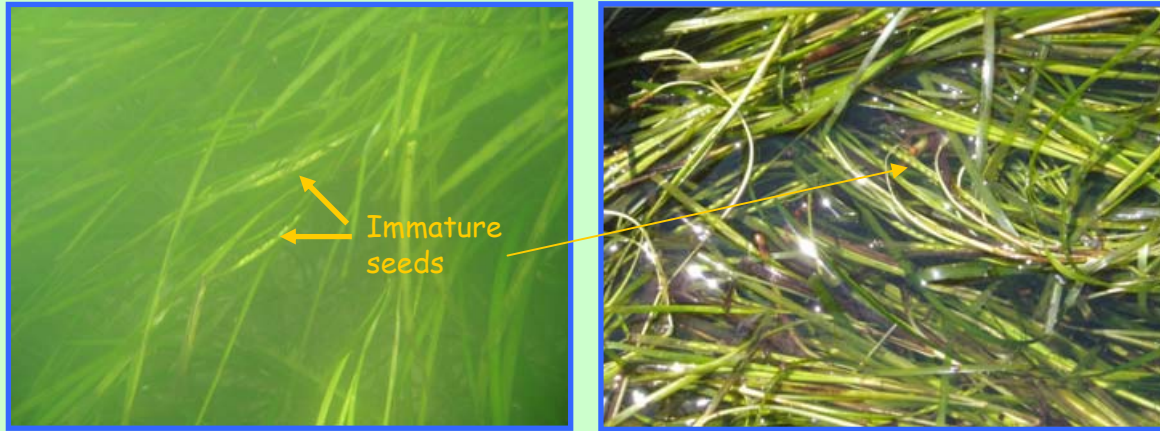
Figure 4. Clockwise from above left: flowering shoots in the water and after harvesting, sieving out leaves, and cleaned seeds.

We harvested flowering shoots from Nahant in July and kept them in a flow-through seawater tank at the Marine Biological Laboratory in Woods Hole until they ripened and dropped from the leaves (Figure 4). We then collected and sorted the seeds by extensive sieving. Seeds were stored in smaller tanks until we were ready to plant them.

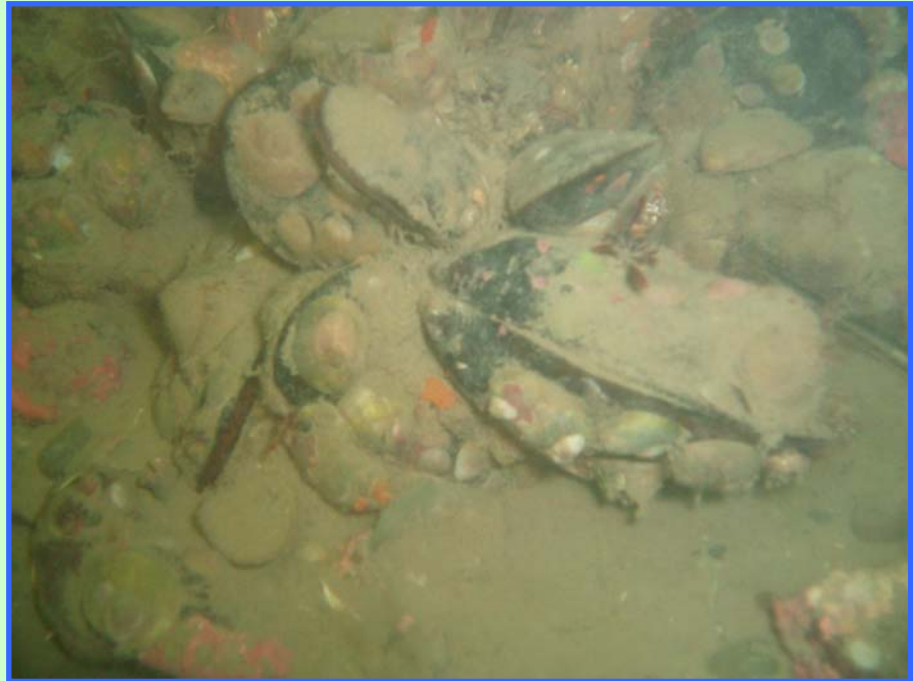
Figure 6. View of a mussel bed. This species exhibits a high water filtration rate.

During the off-season of winter 2006 we will further investigate the feasibility of co-planting shellfish with eelgrass (Figure 6). Shellfish feed by filtering particles from the water and in large numbers can have a significant positive impact on water clarity in a localized area. Improved light penetration favors eelgrass survival and growth.

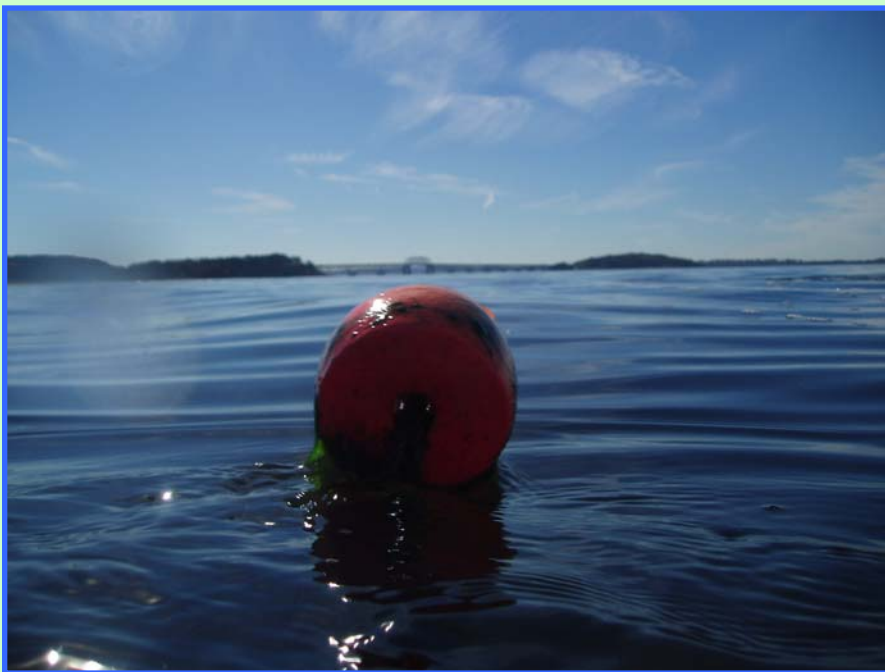
Figure 7. A buoy marks a planted site off Long Island. The Long Island Bridge is in the background.

Monitoring of our planted sites will resume next field season to catalog survival. Comparisons of planted sites (e.g., buoyed Figure 7) to control sites will be initiated to evaluate species abundance and diversity.
